# CLIMATE CHANGE AND GEOMORPHOLOGICAL HAZARDS IN THE CANADIAN CORDILLERA; THE ANATOMY OF IMPACTS AND SOME TOOLS FOR ADAPTATION

Scientific Report 1999-2001 – Summary of Activities and Results

Climate Change Action Fund Project A099

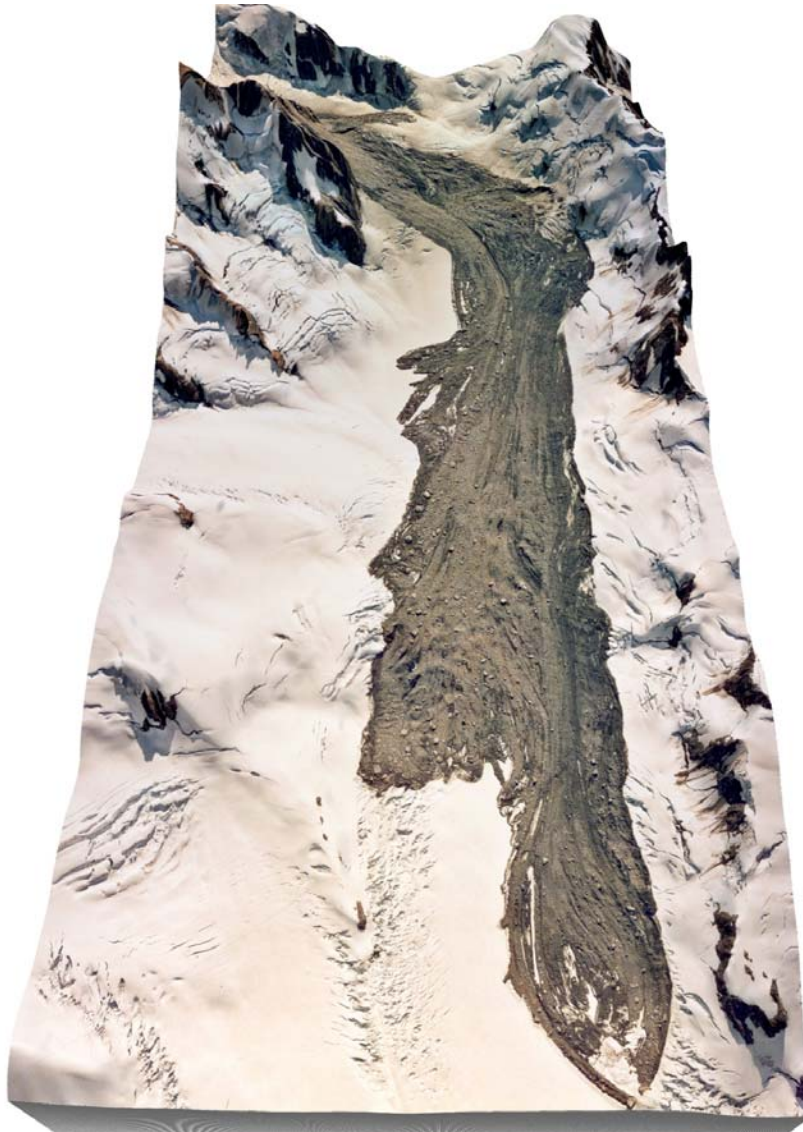
Fig. 1 ; Perspective view of the Mount Munday rock avalanche on Ice Valley Glacier, Waddington Range, southern Coast Mountains. This digital image was prepared from aerial photographs flown on August 20, 1997, and consists of a DEM with an orthophoto drape. Note flow lines in the debris. Elevation of the top of the source area is 3000 m.a.s.l. and the lower tip of the debris is at 2100 m.a.s.l. The length of the rock avalanche path is 4.7 km.

**3. Rock avalanches onto glaciers in British Columbia;** studies on Kendall Glacier, Tim Williams Glacier, Ice Valley Glacier (Mt. Munday; see Fig. 1) Kshwan Glacier, and Fubar Glacier (Telkwa Pass; see Fig. 2), rock avalanches showed that glacier

debutressing was important in initial failure and that in general the debris moved further over the glacier ice surface than it would have over a non-glacier ice surface. High density DEMs have assisted in the geotechnical characterization of these rock avalanches and have enabled the calculation of detailed quantitative parameters such as failure volume and run-out distance.

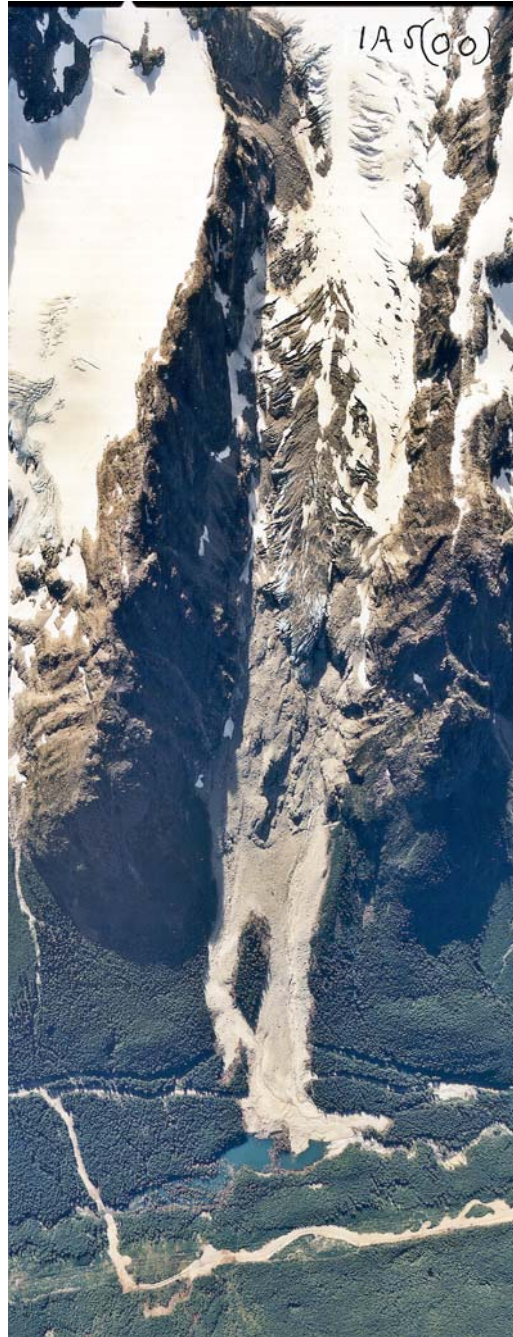
Fig. 2; September 1999 rock avalanche at Fubar Glacier, Telkwa Pass, Coast Mountains, British Columbia.

In September 1999 a rock avalanche originating above the Fubar Glacier, ran down over the glacier and into the valley bottom of Telkwa Pass (see aerial photograph at left). In doing so, it severed two natural gas pipelines that supplied Terrace and Kitimat. Because of the loss of gas supply four large plants were closed in both towns (see press cutting below from *The Province*, September 13<sup>th</sup>, 1999). The pipeline was re-laid around possible run-out of a new rock avalanche (see aerial photograph). Aerial photographs were flown specially for the project in August 2000.

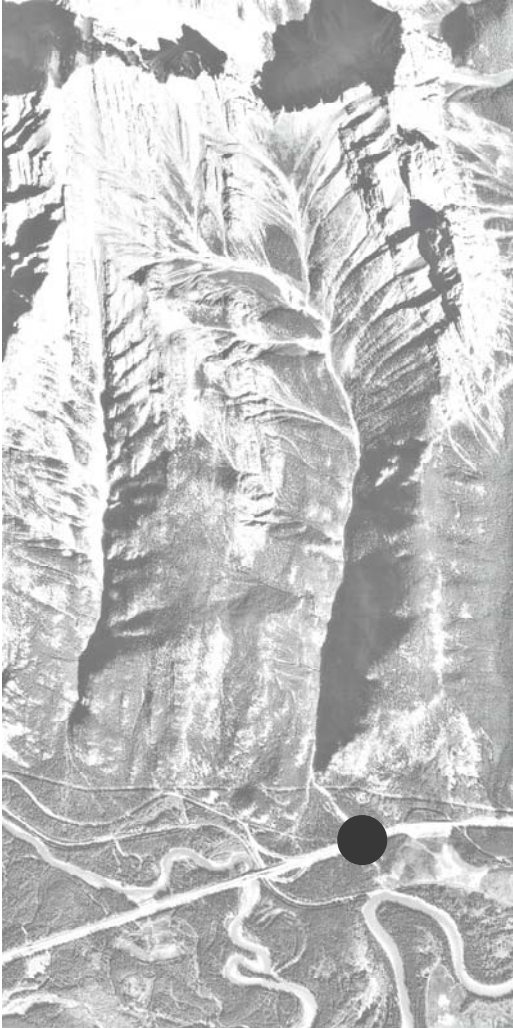
Fig. 3: Aerial photograph flown in September 1999 of % Mile Creek basin, Rocky Mountains, Banff National Park, Alberta. Bow River valley is visible in lower part of the photograph. The August 1999 debris flow originated in multiple locations within the upper part of the drainage and traveled down the creek bed to block the Trans-Canada Highway running right to left. Blockage location is denoted by black spot. The debris flow is thought to have been triggered by a very localized microburst rainfall in the upper reaches of the watershed. The debris flow blocked the Trans-Canada Highway for several days at the height of the tourist season. Aerial photographs flown specially for this project by Foto-Flight, Calgary, Alberta.

5-Mile Creek debris flow, Banff National Park: In August 1999 a debris flow occurred in the Rocky Mountains at 5-Mile Creek in the Bow Valley, Alberta. The event blocked the Trans-Canada highway for several days at the peak of the tourist season (*The Globe and Mail*, August 6, 1999; Fig. 3). The debris flow was apparently triggered by an afternoon highly localised microburst rainfall, which went unrecorded by the hydrometeorological network. Whilst rainfall-triggered debris flows in the Coast Mountains are well documented, Rocky Mountain debris flows show distinctive characteristics that are not. Some of these characteristics include multiple sources for the debris flow (Fig. 3), sheet mobilization of colluvium and substantial entrainment from channel locations.
